# Hardware Key not detected after Windows 10 upgrade to Version 1803

## Article Number

2018005

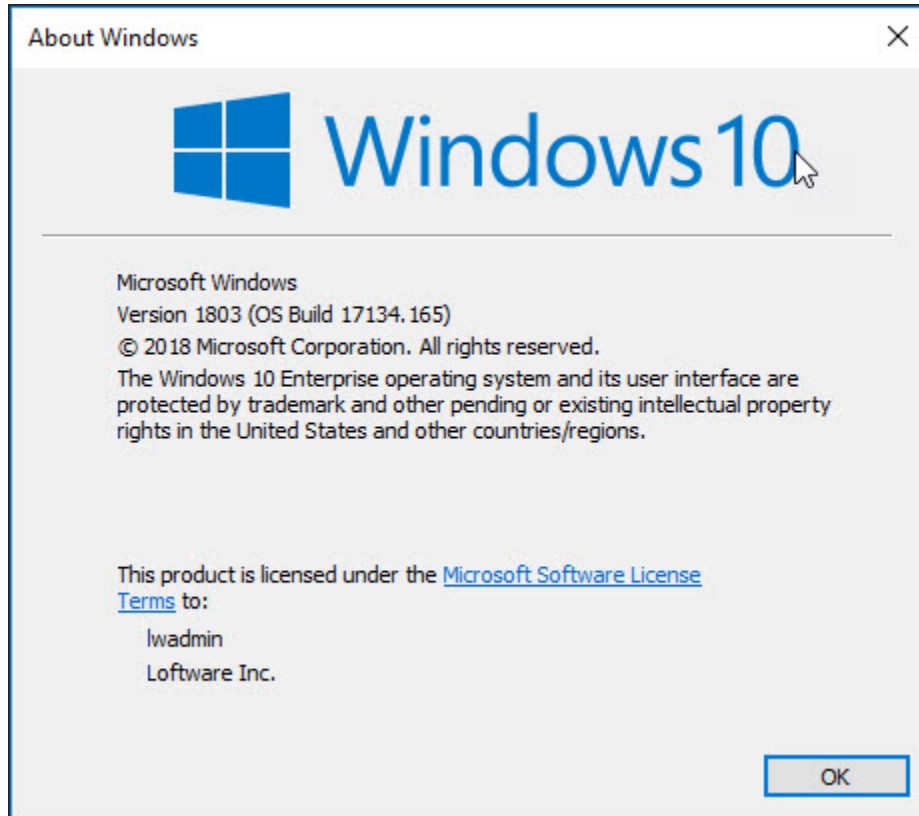
A Loftware Label Manager or Loftware Print Server hardware key is not being recognized after **Windows 10** is upgraded to **Version 1803**.

The upgrade to Windows 10 Version 1803 can deactivate the Sentinel System Driver functionality required for the Loftware hardware keys to work

To correct the issue, re-run the **Sentinel System Driver <ver> Installer.exe** (ver may vary) located on the Loftware computer, in the **Loftware Labeling\DIAGNOST\Sentinel** folder
