Hardware Key not detected after Windows 10 upgrade to Version 1803

2018005

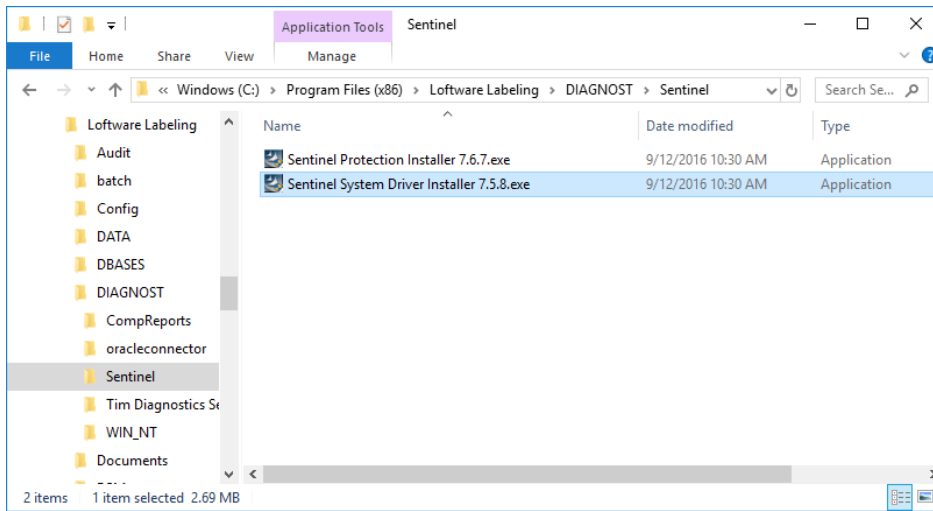
The upgrade to Windows 10 Version 1803 can deactivate the Sentinel System Driver functionality required for the Loftware hardware keys to work

To correct the issue, re-run the **Sentinel System Driver <ver> Installer.exe** (ver may vary) located on the Loftware computer, in the **Loftware Labeling\DIAGNOST\Sentinel** folder
