# Hardware Key not detected after Windows 10 upgrade to Version 1803

## Article Number

2018005

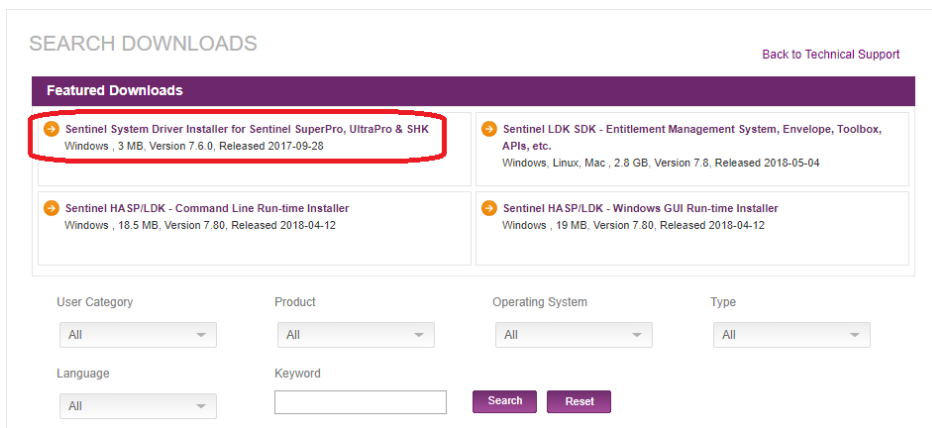
If the driver is missing from your Loftware computer, it may be downloaded below

<https://sentinelcustomer.gemalto.com/sentineldownloads/>.
