Hardware Key not detected after Windows 10 upgrade to Version 1803

2018005

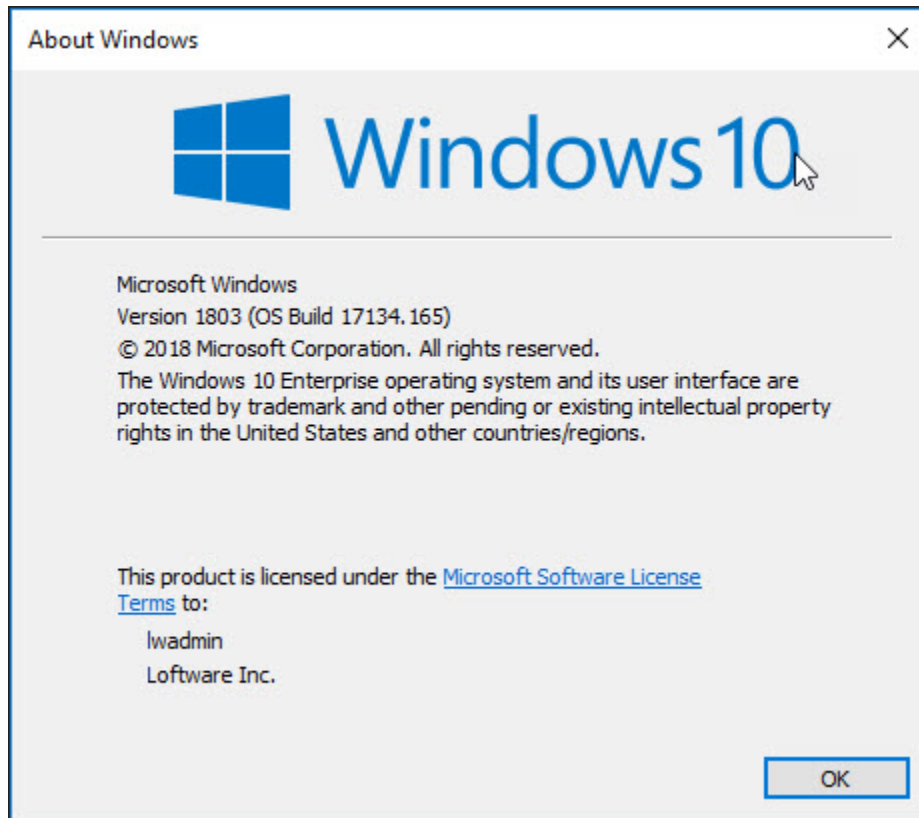
A Loftware Label Manager or Loftware Print Server hardware key is not being recognized after **Windows 10** is upgraded to **Version 1803**.

The upgrade to Windows 10 Version 1803 can deactivate the Sentinel System Driver functionality required for the Loftware hardware keys to work

To correct the issue, re-run the **Sentinel System Driver <ver> Installer.exe** (ver may vary) located on the Loftware computer, in the **Loftware Labeling\DIAGNOST\Sentinel** folder
